**North Slope of Alaska ARM Facilities
Monthly Status Update
Sandia National Labs**

July 2017

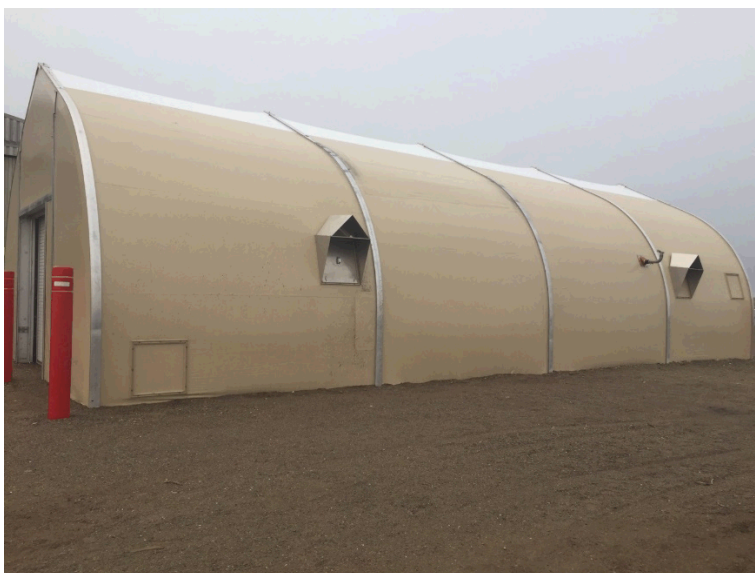
Sprung structure repaired

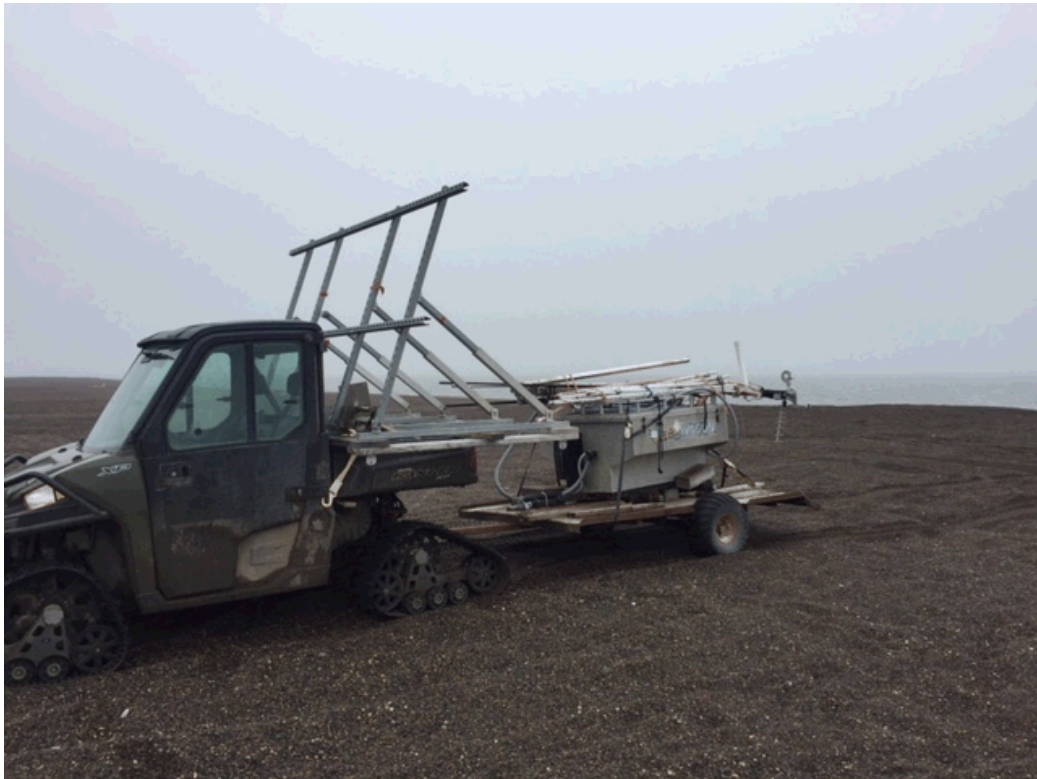
Tower and battery controls removed from Pt. Barrow/ECOR

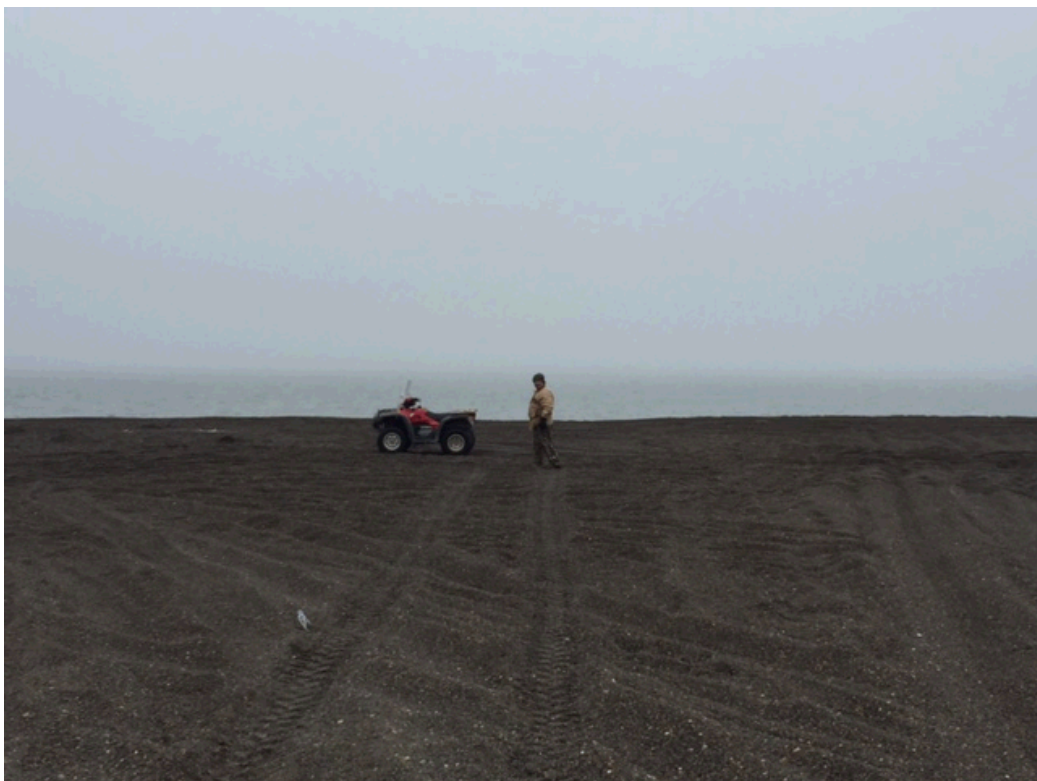
Site left pristine
